REPORT NO. 710/14

TEST OF COMPOSITE PLATES FOR
ARMOR PLATE

Report No. 710/14
Watertown Arsenal

Test of Composite Plates for Armor Plate

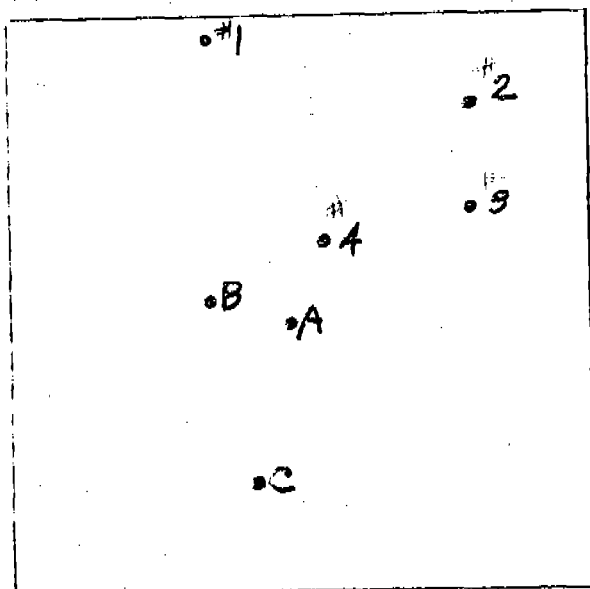
PLATE NO. Combination "A"

Combination "A" plate was put together as one plate without any spacing between the plate; this combination failed completely. The combination of plates was fired both at the front and back. The back of the plate when fired at, gave better results than the front; when fired at the front the cores made complete penetrations, but firing at the back, the cores stayed in the plate, the points just coming through the opposite side.

ROUND NO.	STRIKING VELOCITY	REMARKS
1	2460	
2	"	Comp. penetratio
3	"	"
4	"	"
A	2460	"
B	"	Comp. penetratio
C	"	points of core just through and core stayed in plate.

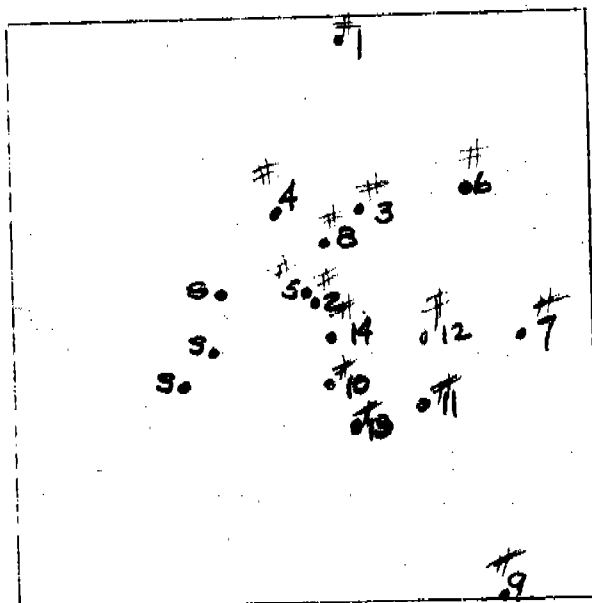
PLATE NO. Combination "B"

This plate was found very good using 2460 f.s. velocity ammunition and Springfield rifle, and plate was sent to Frankford Arsenal for further firing test, the results of which are included within the pages of this report.

S, S, & S.	2460	Bulged dural to face of back plate-no damage on back plate.
------------	------	---

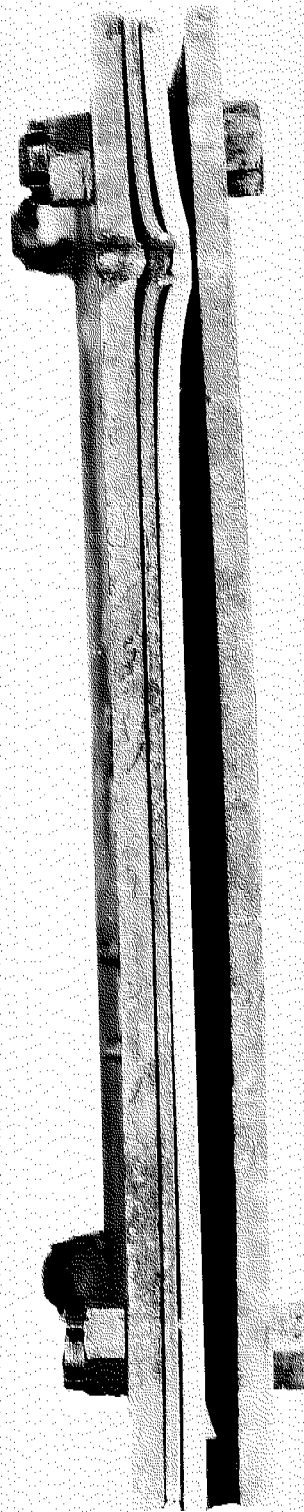
710-25

<u>ROUND NO.</u>	<u>TYPE</u>	<u>STRIKING VELOCITY</u>	<u>REMARKS</u>
SSS (3)	30AP1922	2460 f.s.	Bulged Dural to face of back plate-no damage on back plate.
1	30-24 Gerlich	4000 f.s.	
2	"	"	
3	"	"	Bulged Dural, but not as much as SSS.
4	"	4100 f.s.	In same hold ^e no ^{off} damage, none of these
5	"	"	bothered back plate.
6	30APHVTI	2300 f.s.	No damage to back plate-these rounds
7	"	"	were not best Ammunition-some old bullets-
8	"	"	can't count so much.
9	"	"	
10	"	"	Partial-star crack-point of core shows 1/16" bulge.
11	"	"	Complete-went through drilled holes in back plate.
12	"	"	CIP-would have been complete except back-stop held core.
13	"	"	Same as 12.
14	"	"	Same as 10
